Manhole Inspection Summary

Manhole # S13CC_013MH

Insp Date: **9/21/07 9:58 AM**

Location Address: **ALLEY OF ELLICOTT DWY**

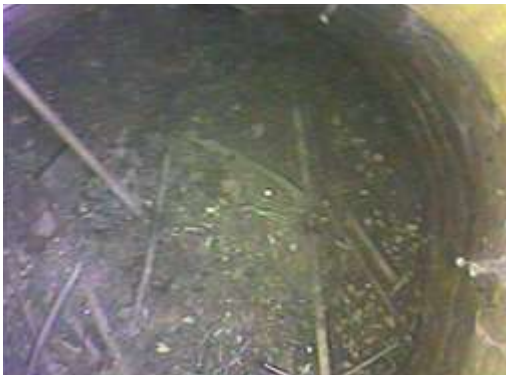
Defect 1

Condition: ☐ Sound ☐ Cracked ☐ Root Intrusion ☐ Deteriorated ☐ Leaks ☒ **Debris**

DEBRIS

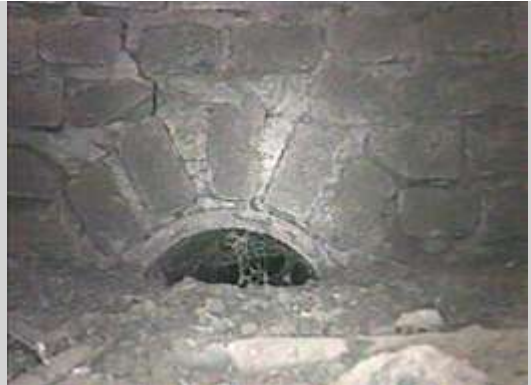
12 O'Clock Outflow

8 in. Circular Gravity Sewer
Pipe Out @ 12 O'Clock

Deposits: ☐ None ☐ Mud ☐ Sludge ☒ **Debris** ☐ Grease

Silt Depth: **5** (in.) Deposits Extent: **Heavy**
